Hydrilla Status and Potential Remediation

Tri-County Lake
Administrative
Commission

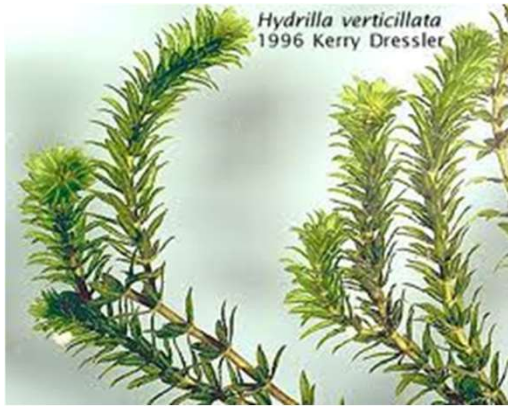
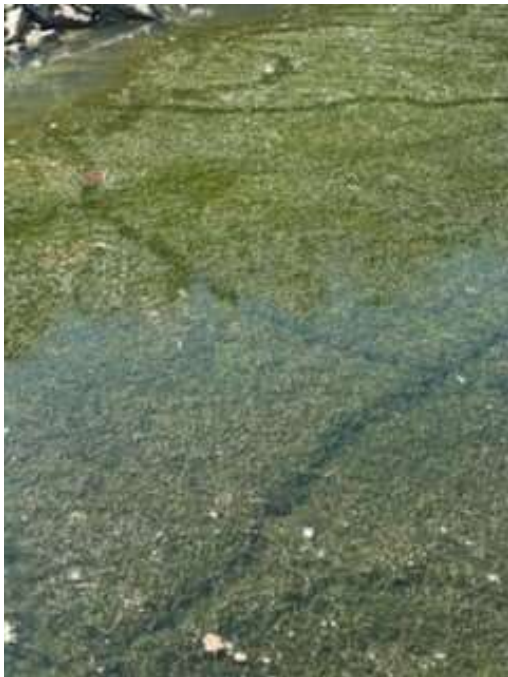
What does Hydrilla look like?

- ▶ Long, sinewy plant with small pointed leaves that are oppositely arranged, generally growing in whorls of five
- ▶ Leaves are sometimes serrated along the edges
- ▶ Flowers are tiny, white, and grown on long stalks
- ▶ Distinct tubers or turions are ¼” to ½” long, off-white to yellowish, potato-like structures that attach to the roots.

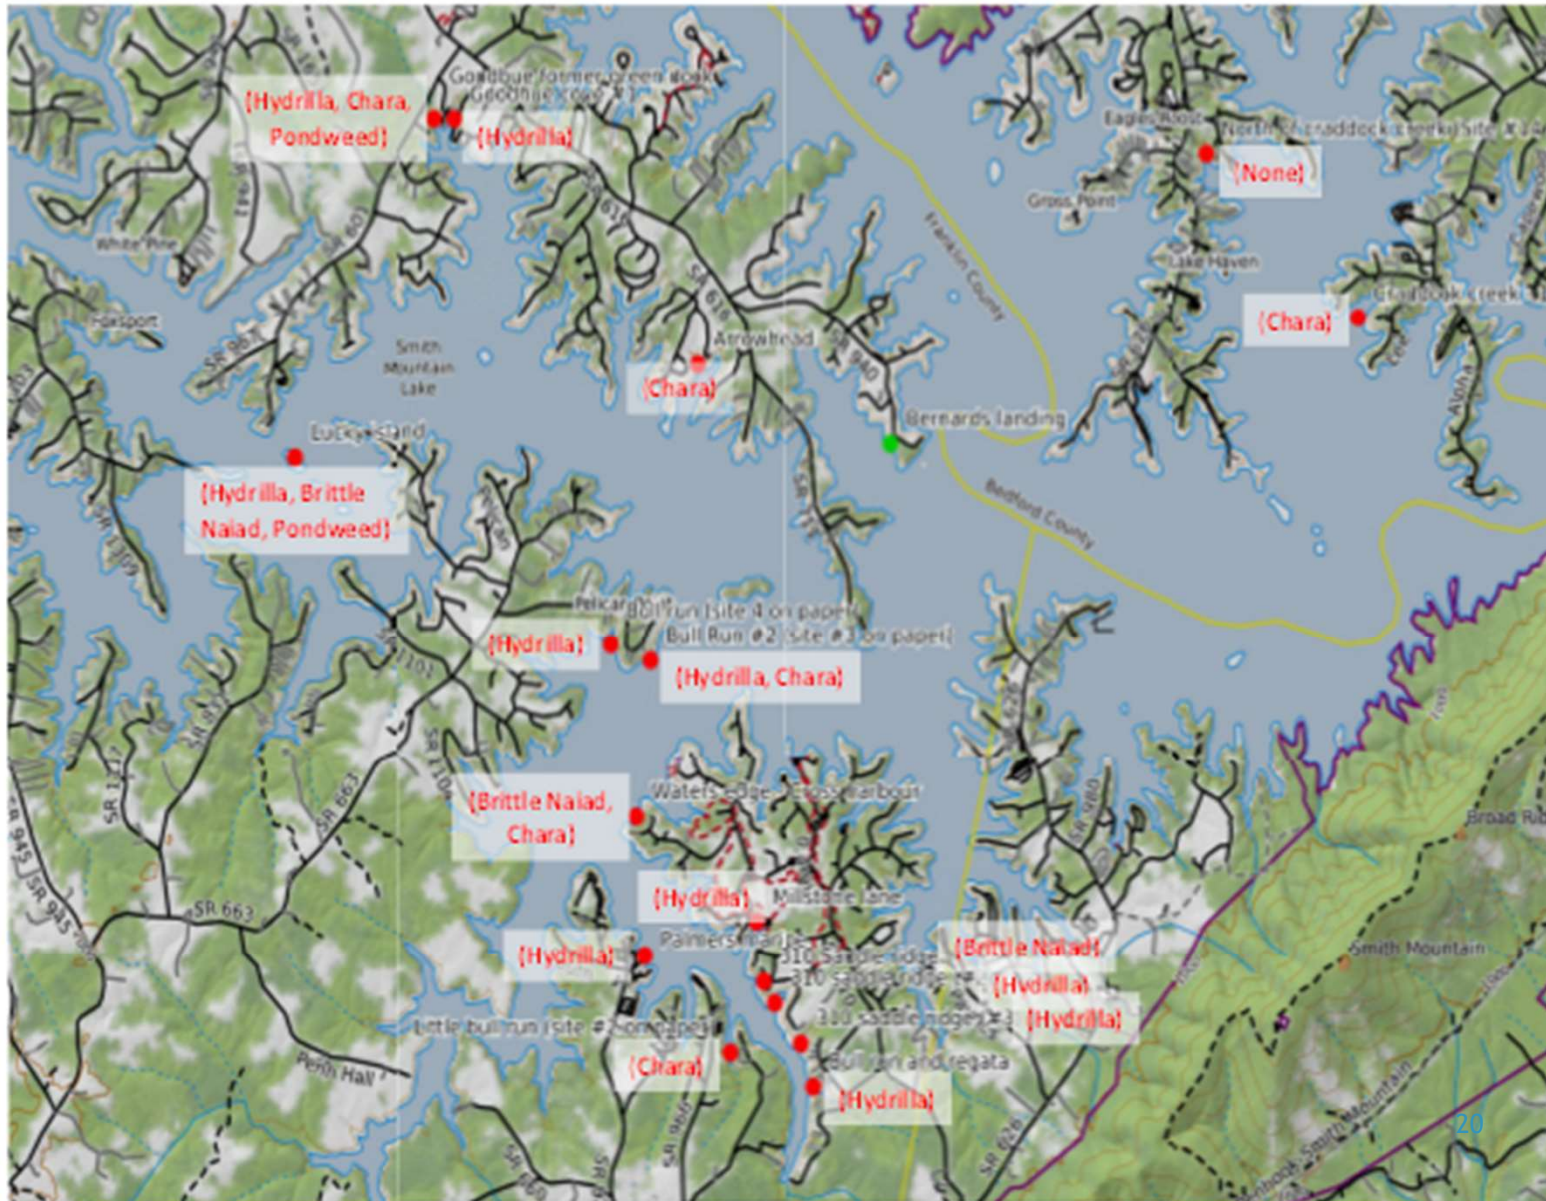
Figure 1

Dive sampling program collected vegetation from 16 sites chosen based upon the historical presence of invasive vegetation. Invasive species, Hydrilla and Brittle naiad, were identified at 12 sites. The extent of the beds was observed to be significantly greater than in 2024.

Dive Site Locations with Observed Vegetation
